# Site and Reach Assessment Union River At SR 300

Work Order MT 0100 Garrett W. Jackson, Hydrologist WSDOT Environmental Services, Watershed Management Program January, 2008

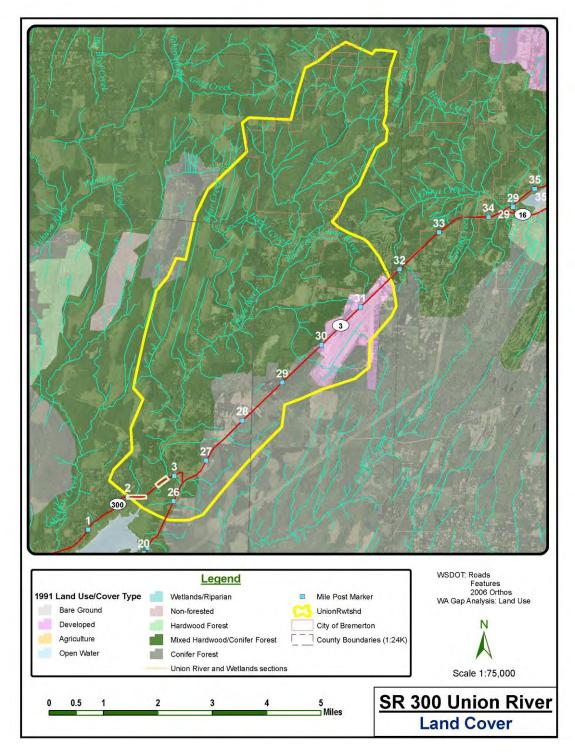
Figure 12. Map of land cover in Union River watershed

Land cover is predominately mixed conifer forest (80 percent). Figure 11 shows the distribution of land cover. The remaining portions of the watershed are in conifer forest (15 percent) and developed areas (5 percent). This watershed is mostly private land, and in a fast-developing area. It is likely that the watershed will experience considerable development in the near future. Within the two sites under consideration, the state owns most of the land on either side of the highway. The Cascade Land Conservancy owns a portion of the estuary adjacent to the highway.

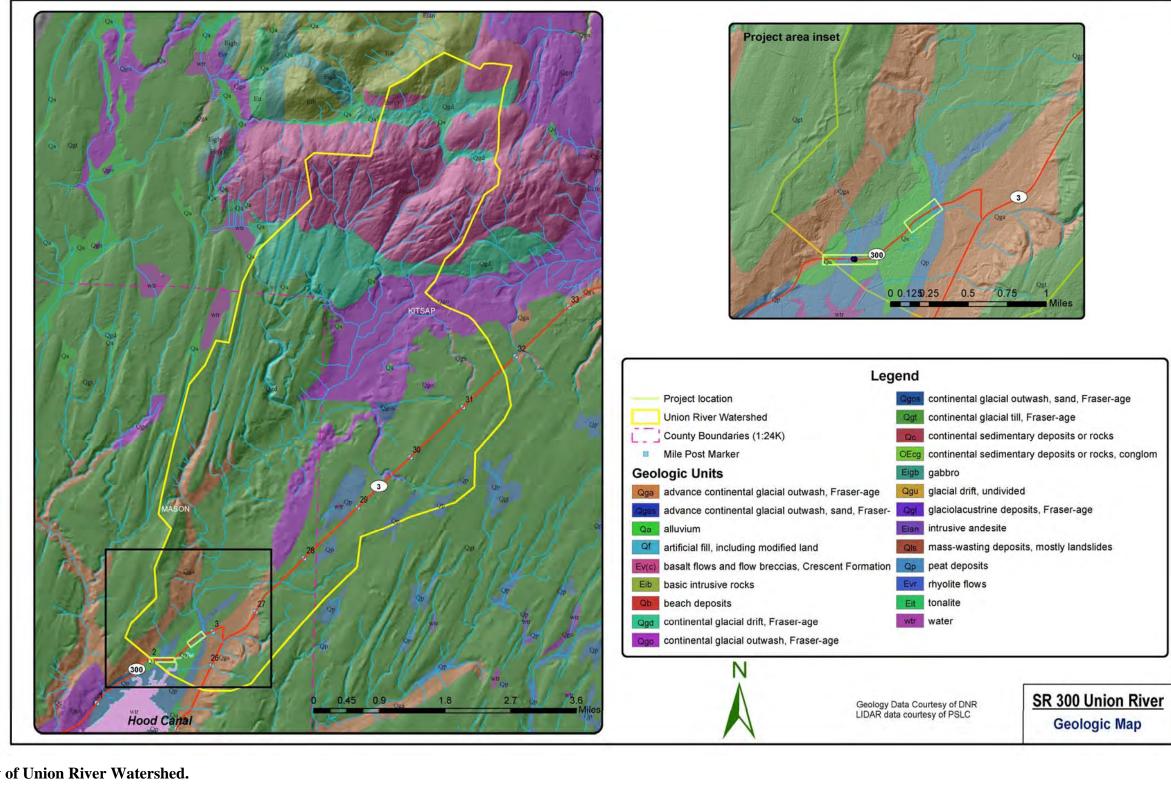
Figure 13. Geology of Union River Watershed.

The upper portion of the watershed is underlain by Eocene volcanic rocks of the Crescent Formation (see Figure 13 for geologic details). These rocks consist of tholeiitic basalt flows, flow breccia, and volcaniclastic conglomerate; gabbro dikes and sills; locally contains thin interbeds of basaltic tuff, chert, red argillite, limestone, and siltstone; rare andesite, dacite, and rhyolite. The lower portion of the watershed is underlain by glacial drift, till, and outwash from the most recent advance and retreat of the Cordilleran Ice Sheet. Holocene alluvium is present in the floodplain of the Union River, and in the alluvial fans of small tributary streams entering the floodplain from the plateaus on either side. In both the Union River section and the wetlands section, the highway crosses peat deposits (see inset in Figure 13). Between the peat deposits, Quaternary alluvium (probably floodplain deposits of the Union River) are present. The floodplain is inset into advance glacial outwash.

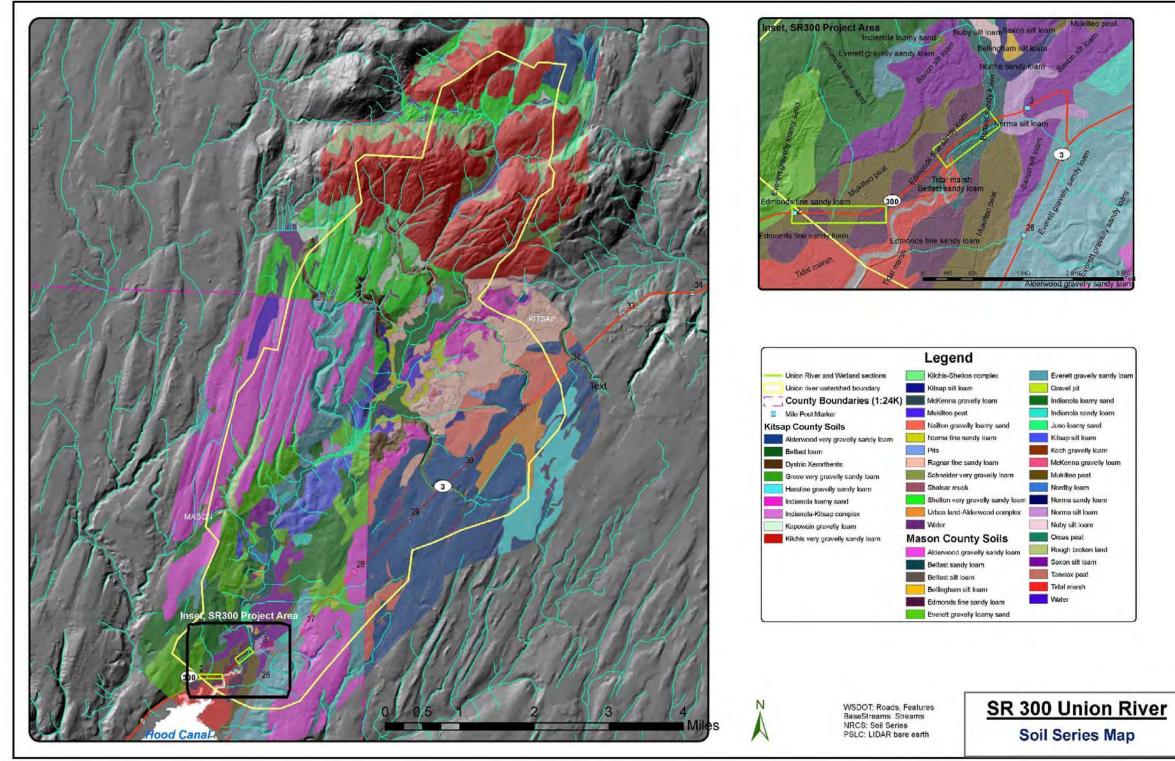
Figure 14. Soil series map of the Union River Watershed.

Basin soils consist of a highly erodible mix of glacial outwash silt, sand, and gravel. Most eroded material is deposited near the river mouth as alluvial floodplain and mudflat sediments. Not surprisingly, soils of the project area are dominated by hydric soils, as shown in Figure 14. Soils of the area include shallow peat over gravel, tidal marsh (in the downslope direction), sandy loam in the river floodplain, and fine sandy loam at the base of the valley sidewall. The upper watershed is dominated by silt loam in the Gold Mountain area, and by gravelly loam on the plateaus. Reflecting the geology of the project site, the Union River floodplain soils are dominated by peat, indicative of the wetlands, and by sandy loam, which is indicative of the floodplain deposits (see inset in Figure 14).

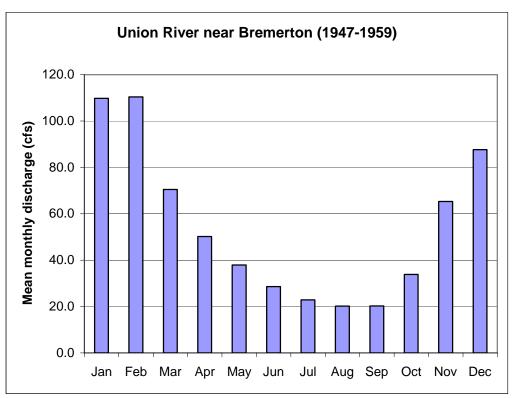
# Figure 15. Mean monthly hydrograph, Union River near Bremerton.

The Union River drains about 24 square miles of Puget Sound lowland and hills. The watershed is a rain-dominated system, not influenced by snowmelt or by rain-on-snow events. As such, the peak flows occur during the winter rainy season. The United States Geological Survey (USGS) maintained a gage approximately three miles upstream from the bridge for 12 years, between 1947 and 1959. The mean monthly hydrograph is shown in Figure 15. Because the gage location is upstream, and because the period of record is short, we used U.S. Geological Survey's StreamStats program to estimate the peak flows for the Union River at the SR 300 bridge; the results are shown in Table 1. The two-year flow event is about 700 cubic feet per second (cfs), while the 100-year flow is about 2000 cfs.

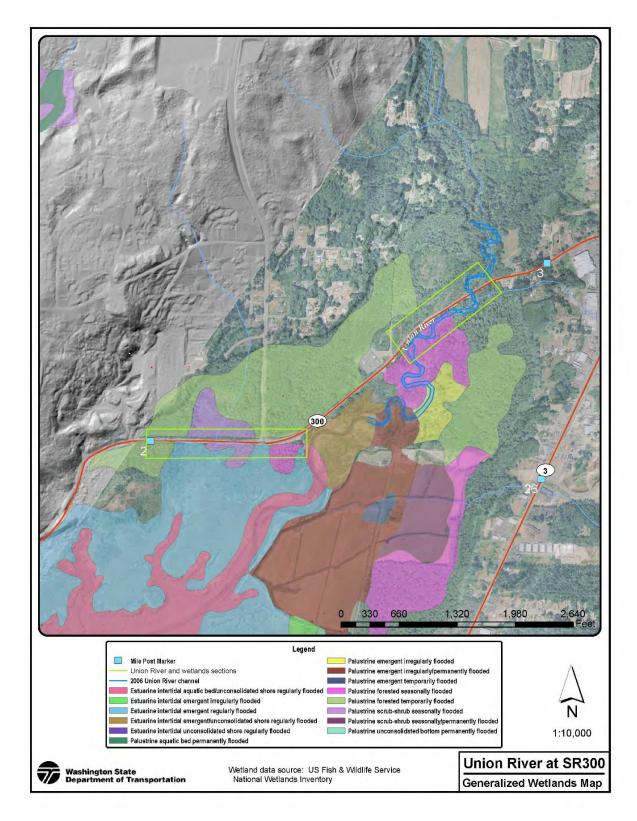
Figure 19. Wetlands and Hydric soils of the project area.

Both sections of the site have considerable wetlands present. Figure 19 shows the wetlands from the National Wetland Inventory. This map gives a basic understanding of the types of wetlands present, and indicate the great extent of wetland in the project area.

The Union River section also has wetlands. These are primarily riverine wetlands (see Figure 19).

One alternative was examined that addresses both the Union River section and the wetlands section, road relocation. Road relocation would involve finding a new route that would cross the Union River farther upstream, and avoid impacting wetlands (see Figure 19). The road would be abandoned and the wetland section restored. The existing bridge would be removed. The highway east of the Union River bridge to the intersection with NE Old Belfair Highway would remain in place to provide local access.
